**Docket No. 217 – Development and Management Plan Inspection**

Northeast Utilities Service Company Certificate of Environmental Compatibility and Public Need for the construction of a 345-kV electric transmission line and reconstruction of an existing 115-kV electric transmission line between Connecticut Light and Power Company's Plumtree Substation in Bethel, through the towns of Redding, Weston, and Wilton, and to the Norwalk Substation in Norwalk, Connecticut.

**Date:** December 14, 2005

**Location:** Transition Stations: Hoyts Hill, Archers Lane, Norwalk Junction

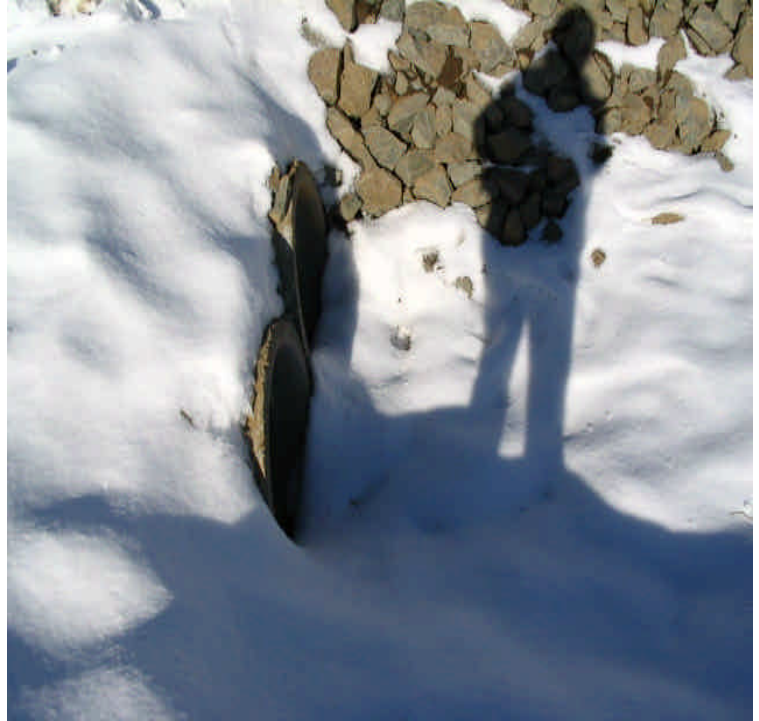
Photo on the left shows the completed drainage swale along the access road. Erosion control matting was installed on the slope here. A haybale should be placed at the inlet or outlet for now until the surrounding area is stabilized. 12/14/05
